URGENT: MEDICAL DEVICE CORRECTION
Ceiling Lift Operator & Service Manual Updates

RE: Tollos Cirrus 450, 600, 700 and 750 models, and Pinnacle 1000 Ceiling Lifts

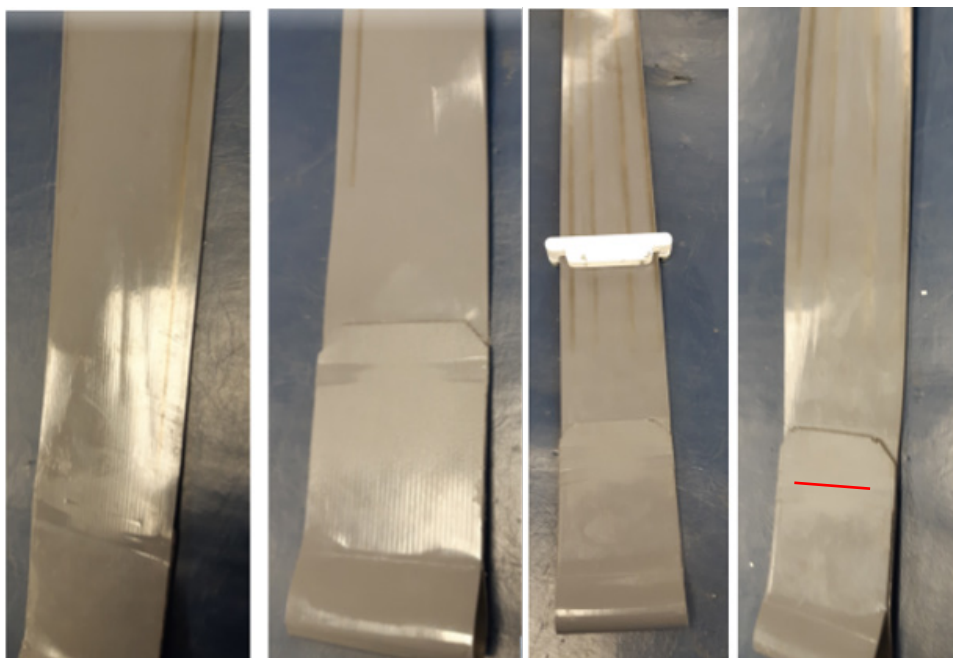
Illustrations 1-4 are examples of IC straps showing signs of normal wear and no structural damage. These straps are safe to continue to use as long as they have not exceeded 10,000 cycles. If the inspected straps are at 10,000 or more lift and lower cycles, then replace the straps.

NOTE: The images below were taken during service activities and the clasp is not shown in the correct position. The correct location of the clasp is just below the fold, shown with the red line on the picture furthest to the right.)

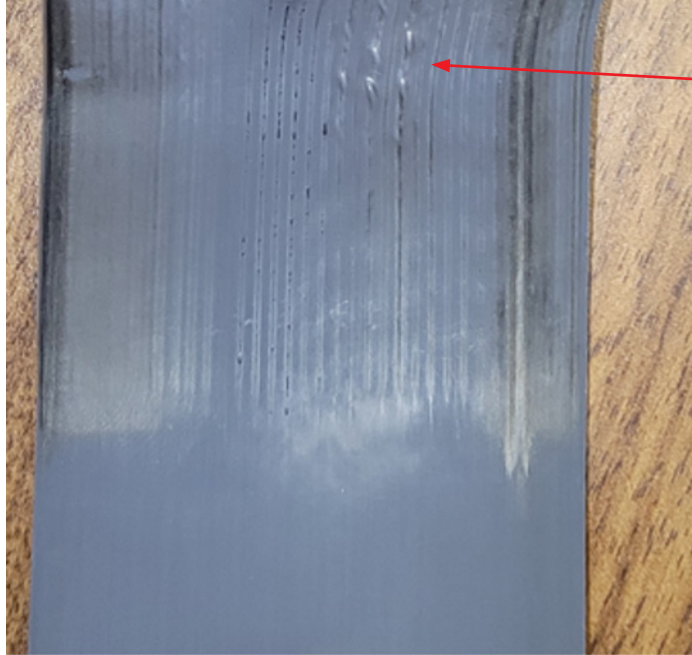
Illustration 5 is an example demonstrating wear to the point that the load bearing internal steel cables are showing. Replace any straps that are worn to this point.

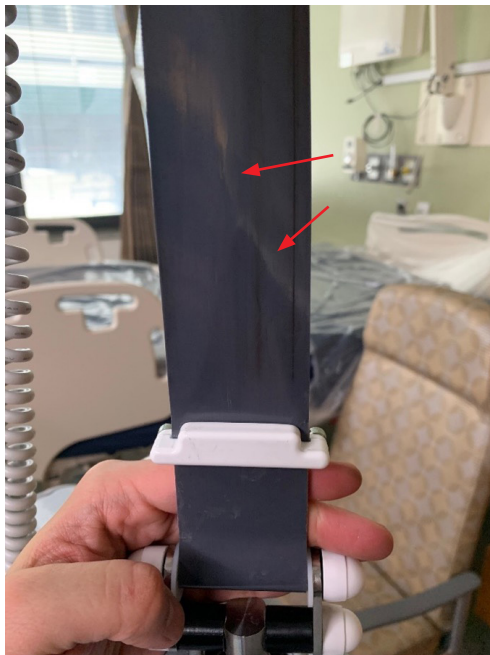
Illustration 6

Illustrations 6-8 demonstrate creasing. If creasing is deep, sometimes coupled with cracks, or if the strap has exceeded 10,000 cycles the strap must be replaced.

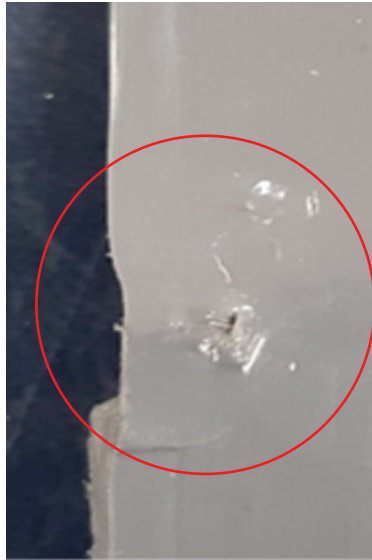
Illustration 9 demonstrates physical damage. Do not use a lift with a damaged strap, and immediately replace any straps found to have physical damage.

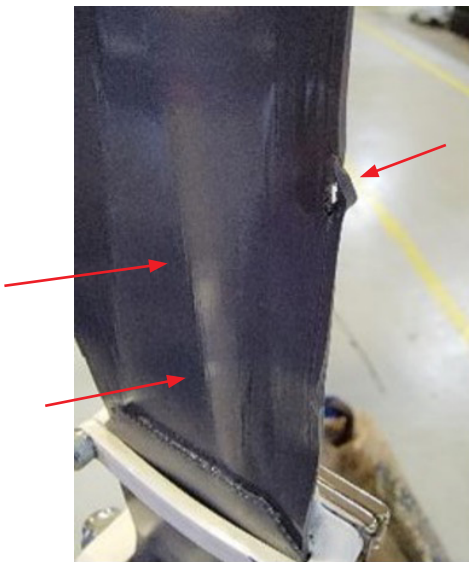
Illustration 10

Illustrations 10 and 11 demonstrate a specific type of physical damage – damage to the edge of the strap. Replace any straps that have this type of damage. (Note that illustration 10 also demonstrates significant creasing.)

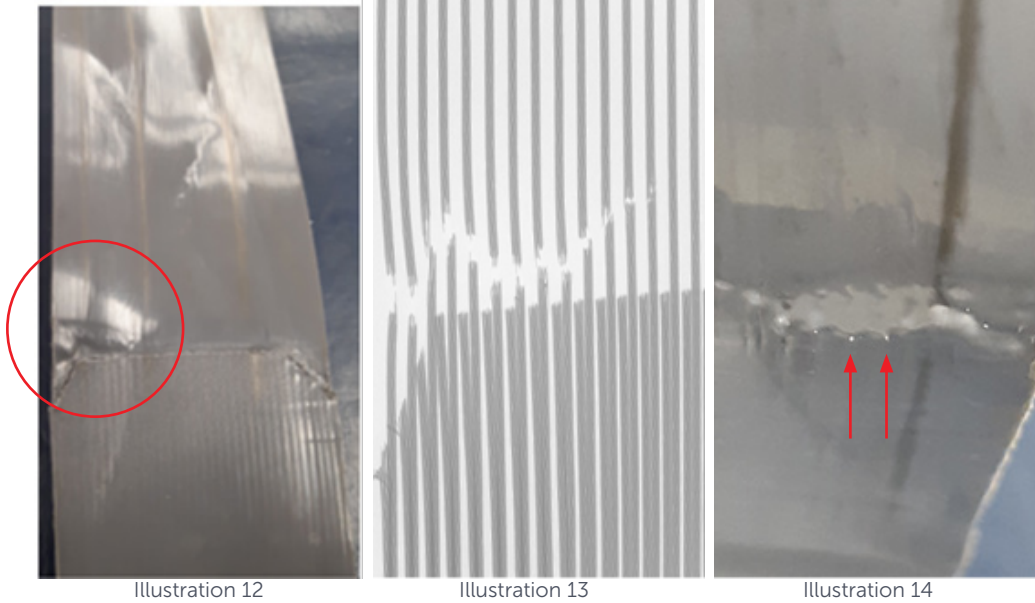
Illustrations 12-14 demonstrates the exterior appearance of a strap with severe damage to the load bearing steel cables internally. An x-ray of this strap is included to show the internal damage that corresponds to the exterior appearance. The close-up image of the opposite side shows the broken cable ends visible through the polyurethane covering. (Note, this strap also demonstrates severe creasing.)
